DIGGING DEEP

to complete NZ's toughest HDD project

A new pipeline was needed to replace a failing cast iron watermain laid during World War 2, which traverses some of the most rugged topography and dense bush imaginable.

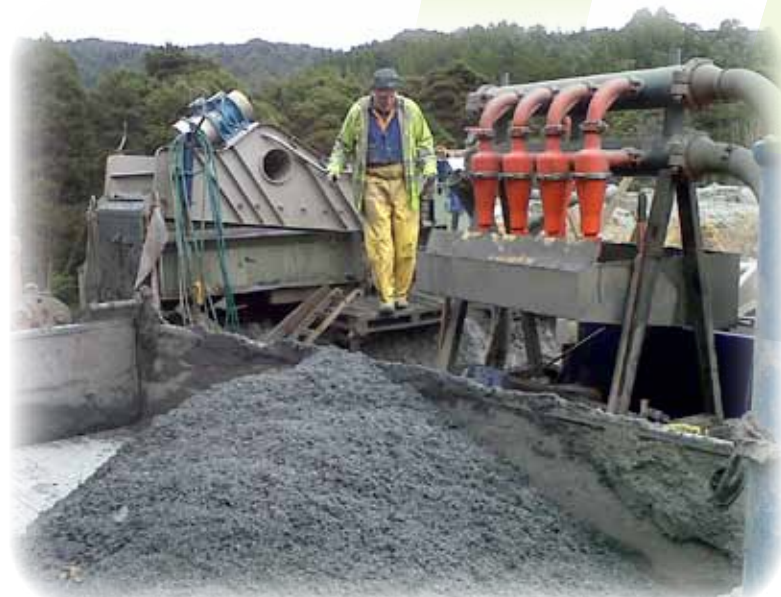
▲ Tunnel cuttings removed from the fluid with 3 shaker screens and 16 hydro cyclones

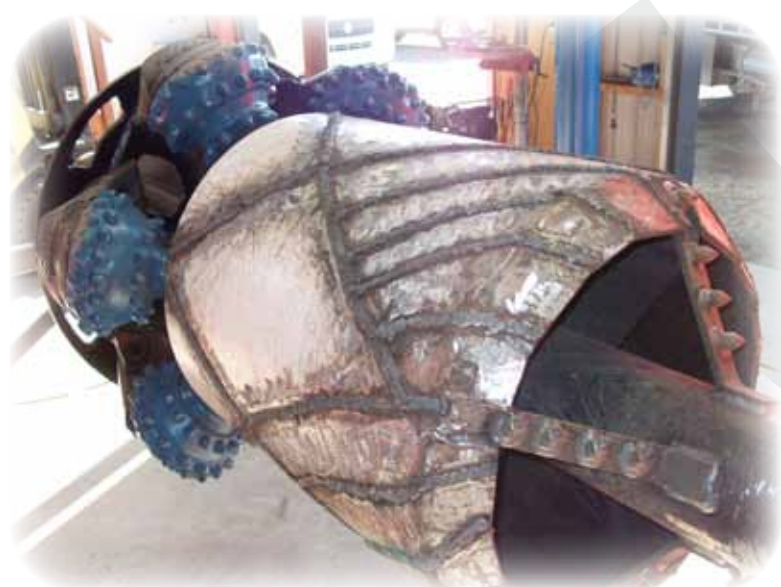
▲ 1050mm diameter tunnel requiring three reamer passes

The pilot hole needed to be enlarged to over 1 meter diameter and this was achieved with three reamer passes. Reaming of the first pass went without difficulty for 800 meters until a sudden tunnel blockage caused the pressure in the tunnel to spike. This caused a tunnel fluid break through at "Tunnel Gully" resulting in a six week delay to the project while environmental preventive measures were established.

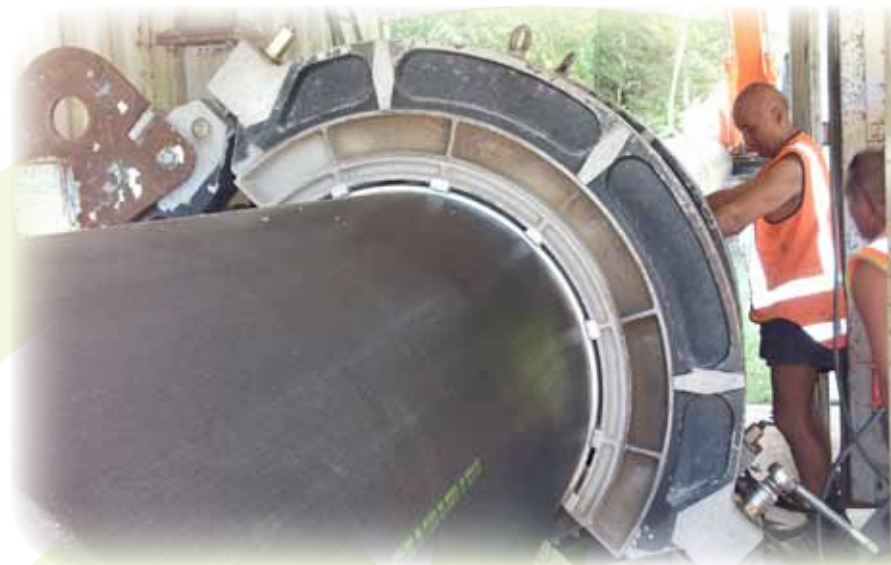
▲ Butt fusion welding of the 850 OD, SDR12 PE pipe.

As the reaming progressed, the 15m long pipes were delivered to the Water filter station where they were welded into two 520 metre strings. Each pipe string weighted almost 100 tons and manuevioring the pipe up a windy metal track proved very difficult. To add to the difficulties there was a requirement to keep the track open to small vehicles in case emergency works were required at the dam head. On completion of the welding the two pipe strings were pressure tested and inspected.

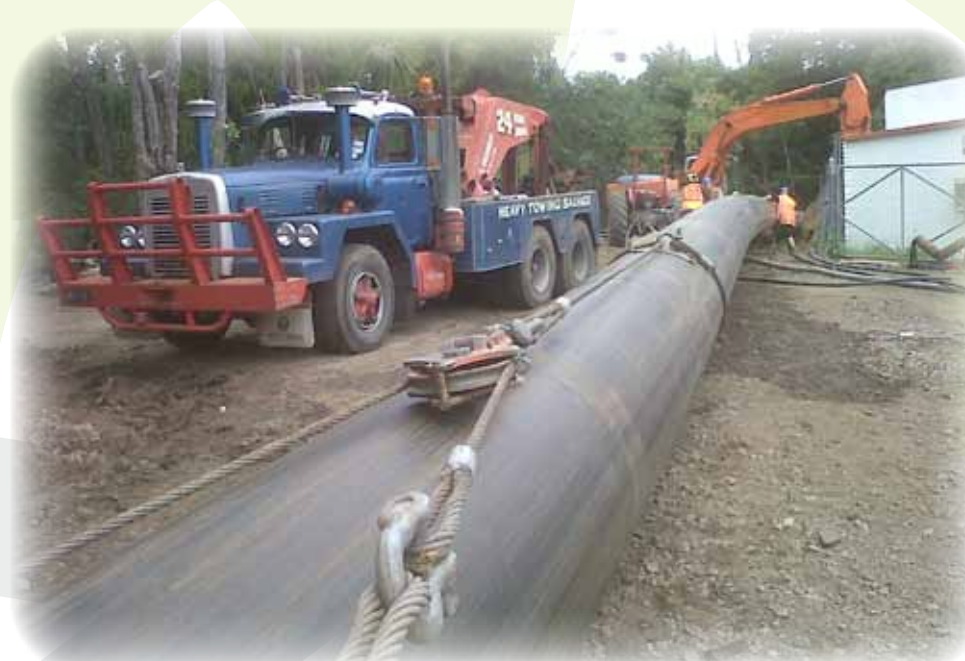
▲ Maneuvering 200 ton of pipe required plenty of grunt

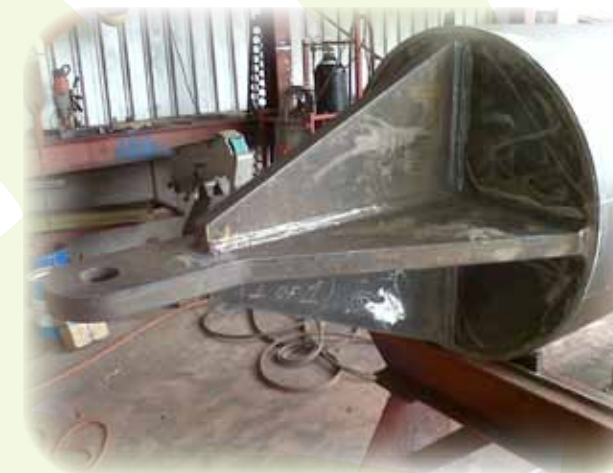
◀ Manufacturing the towing head

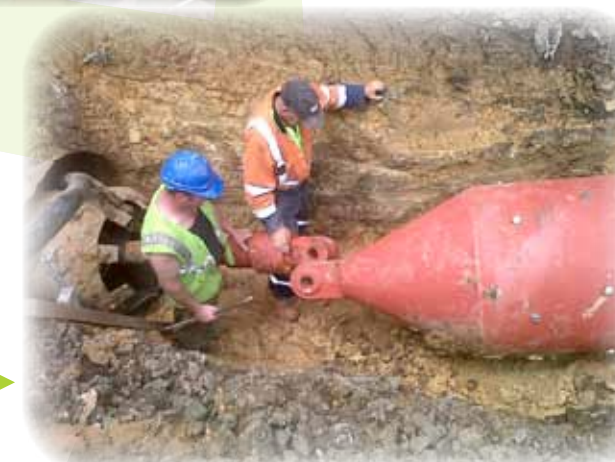
▶ Connecting the towing head to the swivel

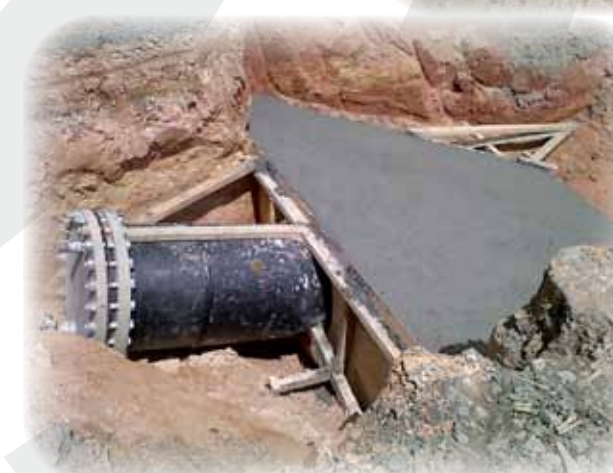
◀ Anchor block construction

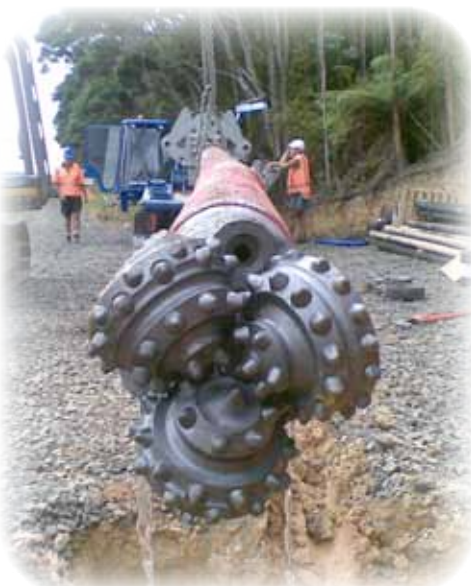
▲ Mud motor with electronic compass steering system

A mud motor with a Digitrak magnetic steering tool was chosen for the pilot hole drilling. The pilot drilling progressed on plan from the low end unit passing under the third stream near the 600m mark. At this location drilling fluid started exiting in a wide area in and around the stream in this gully. This gully was later named "Tunnel Gully" due to its close proximity to the tunnel used for the cast iron pipeline built back in the 1940s. Progressing the pilot hole under this gully led to the drill string becoming jammed.

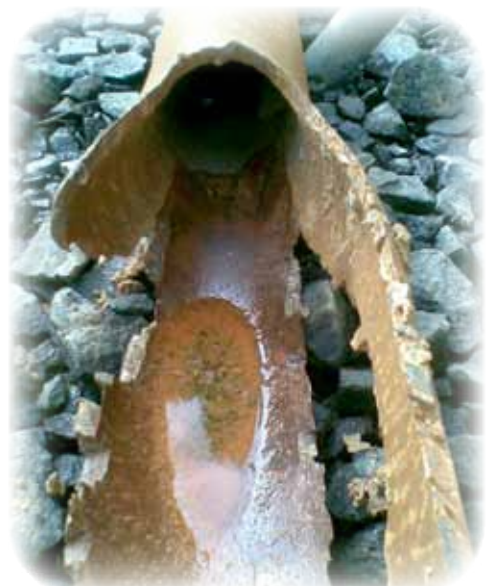
▲ Exploded drill rod to recover drill string

New down hole equipment was ordered from overseas and UUL went about salvaging as much of the drill string from the hole as possible. An explosive charge was feed down the drill string and 350m of rods were eventually recovered.

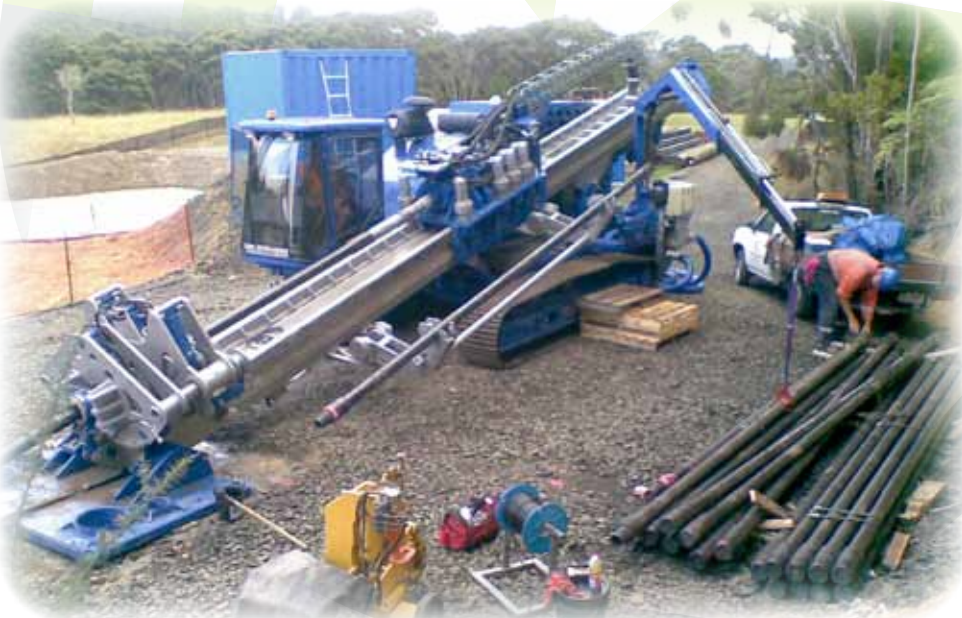
▲ Universal HDD Rig (100 ton pull back)

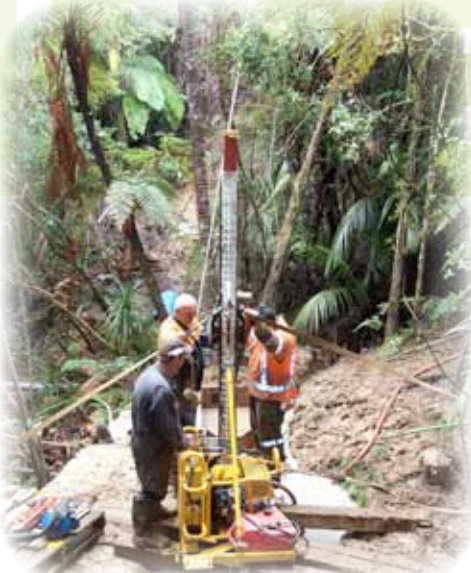
▲ Heli rig used for grout injection and additional ground investigation

A heli drill rig was dropped into the bush and two ground investigation bore holes were drilled revealing substantially weak beds of barely cemented sands.

Grout injection was undertaken in tunnel gully to help stabilise the formation.

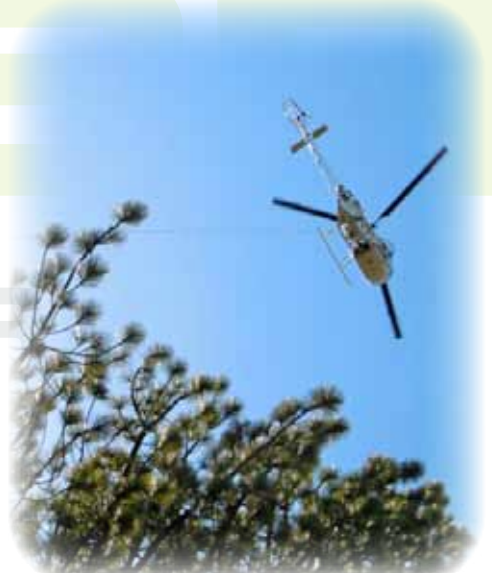
▲ All equipment lifted in and out of tunnel gully by helicopter

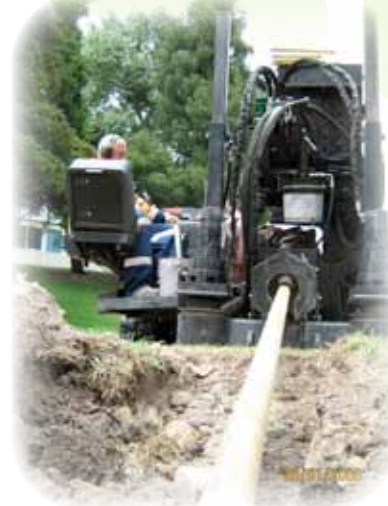
◀ Ditchwitch 30/20 drill rig utilised to drill down to and intercept the existing pilot hole

UUL conceived utilising a small drill rig to drill down the steep embankment and intersect the existing pilot hole nine metres below the stream and 40 metres below the small drill rig platform. The difficulty of this manoeuvre was no small feat. The small drill had to land its drill string into a 260mm diameter pilot hole like landing an aeroplane. Simply drilling straight to the existing pilot hole would not work. The steep and densely vegetated embankment and depth of the drilling made the operation very tricky. The drill string had to achieve a depth of 18 metres before arriving under the stream on line and grade. Every longitudinal metre had a different grade to achieve as it bent around to eventually match the target grade. A survey and computer bore plan was undertaken for the shot and recalculated every 15m.
