# DIGGING DEEP TO COMPLETE NZ'S TOUGHEST HDD PROJECT

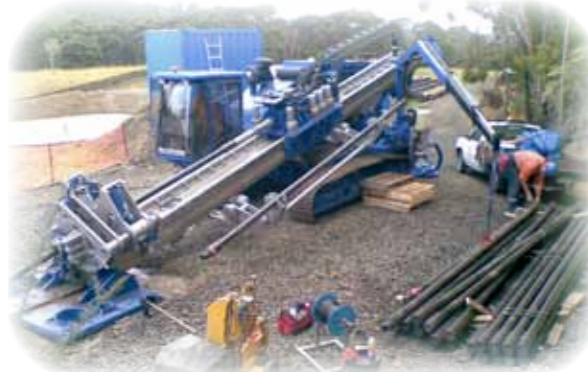
▲ Universal HDD Rig (100 ton pull back)

A Universal 200 x 240 Drill Rig and a mud motor with a Digitrak magnetic steering tool was chosen for the pilot hole drilling. The pilot drilling progressed on plan from the low end unit passing under the third stream near the 600m mark. At this location drilling fluid started exiting in a wide area in and around the stream in this gully. This gully was later named "Tunnel Gully" due to its close proximity to the tunnel used for the cast iron pipeline. Progressing the pilot hole under this gully led to the drill string becoming jammed. A driller's worst nightmare.

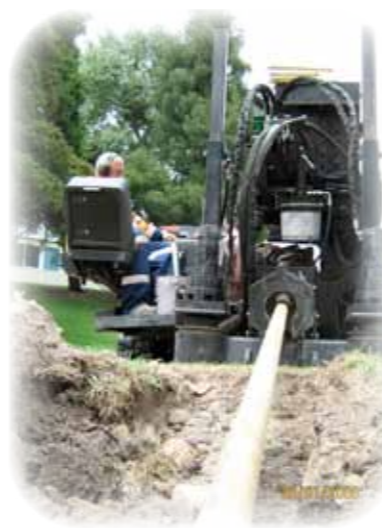
▲ Ditchwitch 30/20 drill rig utilised to drill down to and intercept the existing pilot hole

A small drill rig was established on site and used to drill down the steep embankment and intersect the existing pilot hole 8 metres below the stream and 40 metres below the small drill rig platform. The difficulty of this manoeuvre was no small feat. The small drill had to land its drill string into a 260mm diameter pilot hole like landing an aeroplane. Simply drilling straight to the existing pilot hole would not work. The steep and densely vegetated embankment and depth of the drilling made the operation very tricky. The drill string had to achieve a depth of 18 metres before arriving under the stream on line and grade. Every longitudinal metre had a different grade to achieve as it bent around to eventually match the target grade. A survey and computer bore plan was undertaken for the shot and recalculated every 15m.

Although the interception drilling over shot the stream, the extremely skilled drill operator "Tim Mitchell" successfully landed the drill string into the existing pilot hole creating a 1km path through the job for the first time.

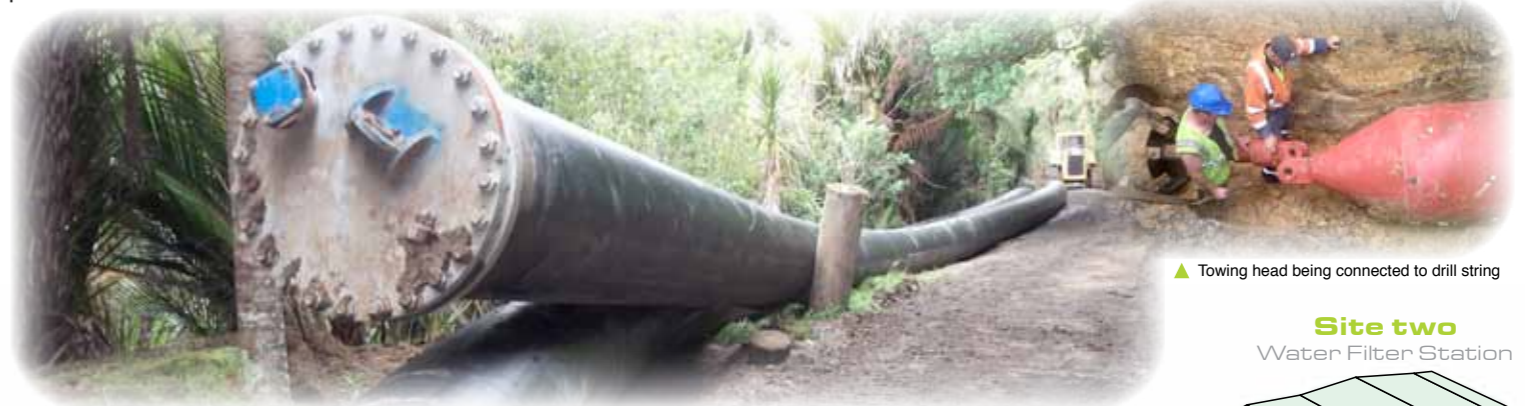
▲ Towing head being connected to drill string

The drill rig was now moved to the bottom platform in order to pull the pipe downhill. A 1.5 ton nose cone was fitted to the pipe and connected to the drill string. One bulldozer winch applying 40 tons of push on a double purchase was set up at the top platform and two winch trucks assisted the pipe as it snaked down the track. When the pulling/pushing forces started to climb water ballast was systematically added into the pipe to manage the pipe/tunnel roof friction. The water volume was carefully monitored because if the pipe was over filled, the water would become dead weight in the empty part of the tunnel. The pipe was installed over a five day period, this included stopping at the midway point to weld the two pipe strings together. Pleasingly the force required to install the 200 ton pipe didn't exceed half of the drills capability.

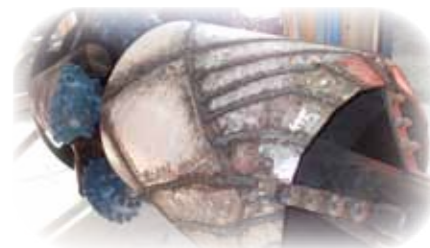
▲ 1050mm diameter tunnel requiring three reamer passes

The pilot hole needed to be enlarged to just over 1 meter diameter and this was achieved with three sizing reamers.

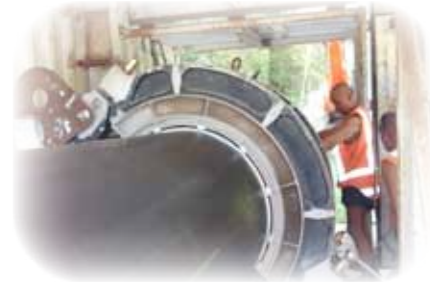
▲ Butt fusion welding of the 850 OD, SDR12 PE pipe.

As the reaming progressed, the 850Ø, 15m long pipes were delivered to the Water filter station where they were welded into two 520 metre strings. Each pipe string weighted almost 100 tons and manoeuvring the pipe up a windy metal track proved very difficult. To add to the difficulties there was a requirement to keep the track open to small vehicles in case emergency works were required at the dam head.
